**PENNSYLVANIA
ID NO. PA.00706**

FURNACE CREEK DAM

**PHASE I INSPECTION REPORT
NATIONAL DAM INSPECTION PROGRAM**

June 1978

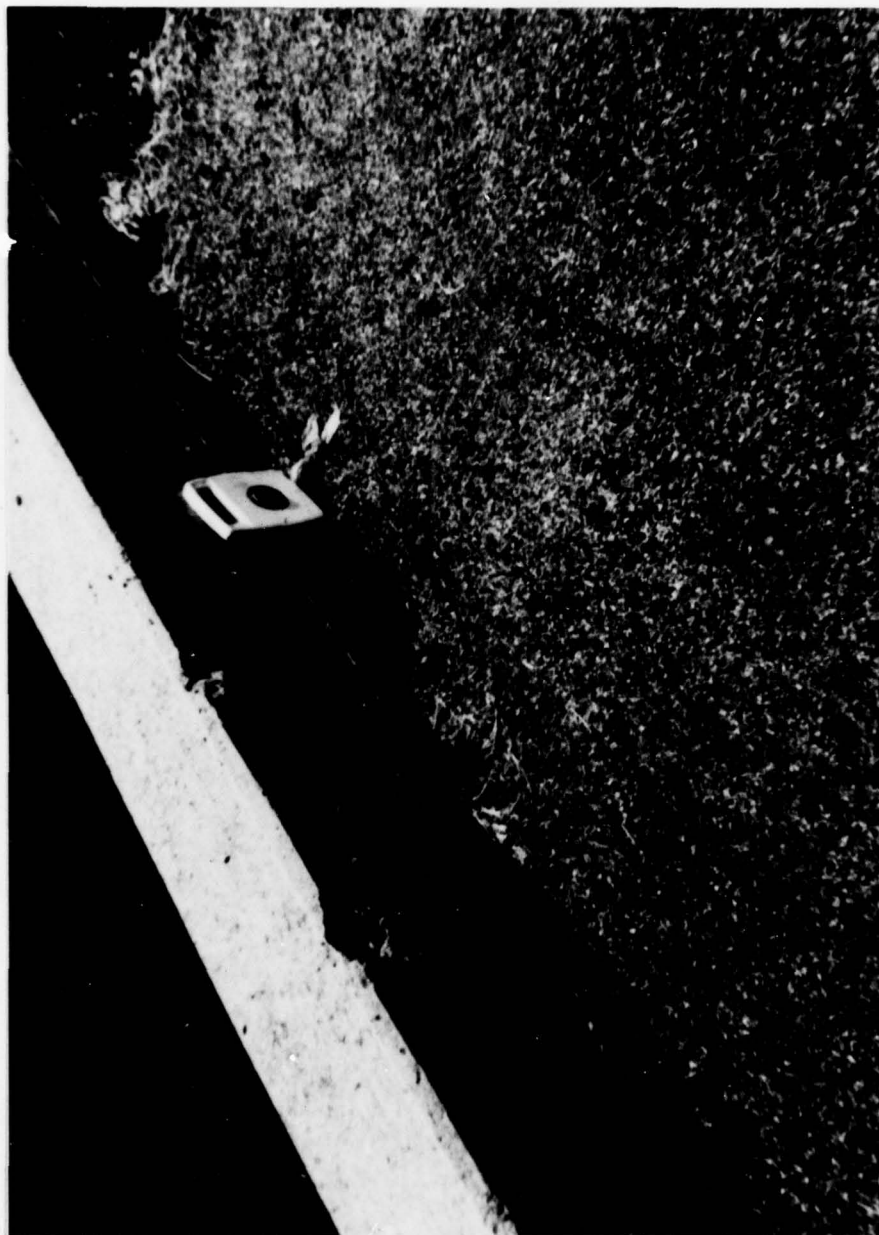
PHOTO NO. 7

It was observed that the crest of the dam was about one foot below the top of the spillway wall. The design drawings indicated the dam crest to be 0.5 feet below the spillway wall so that this observation would indicate about 0.5 feet of settlement adjacent to the spillway. However, the Owner's representative reported that the dam crest was constructed level with the top of the spillway wall so that this observation would indicate about one foot of settlement at this location. Additional observations on the downstream face disclosed a maximum of about one foot of embankment settlement adjacent to the spillway wall.

VISUAL EXAMINATION OF	OBSERVATIONS	REMARKS OR RECOMMENDATIONS
SURFACE CRACKS	None observed	
UNUSUAL MOVEMENT OR CRACKING AT OR BEYOND THE TOE	None observed	
SLOUGHING OR EROSION OF EMBANKMENT AND ABUTMENT SLOPES	None observed	
VERTICAL AND HORIZONTAL ALIGNMENT OF THE CREST	Horizontal alignment along the crest is straight. The crest of the dam is about one foot below the top of spillway wall. Based on design drawings and visual observation, it appears that crest has settled 0.5 feet. Accordingly to Mr. Lutz the dam settled approximately 1 foot. (See Photo No. 7).	
RIPRAP FAILURES	None observed

SETTLEMENT OF DAM CREST AT LEFT SPILLWAY WALL.
PHOTO SHOWS 6 to 12 INCHES OF SETTLEMENT.

As a more feasible means of upgrading the hydraulic capacity of Furnace Creek Dam, it is recommended that the dam crest be raised to the top of the spillway wall. Also, the backfill behind the right spillway wall should be similarly raised. After this work is performed, the spillway is expected to be capable of passing 0.9 PMF. Additional protection against overtopping during the PMF event could be obtained by riprapping or otherwise armoring the downstream slope of the dam.
